**ASBESTOS AND LEAD-BASED PAINT
OPERATIONS & MAINTENANCE PLAN**

**BUILDING #506
FORMER FORT MCPHERSON ARMY BASE
ATLANTA, FULTON COUNTY, GEORGIA**

OASIS PROJECT NO. 163766

October 10, 2017

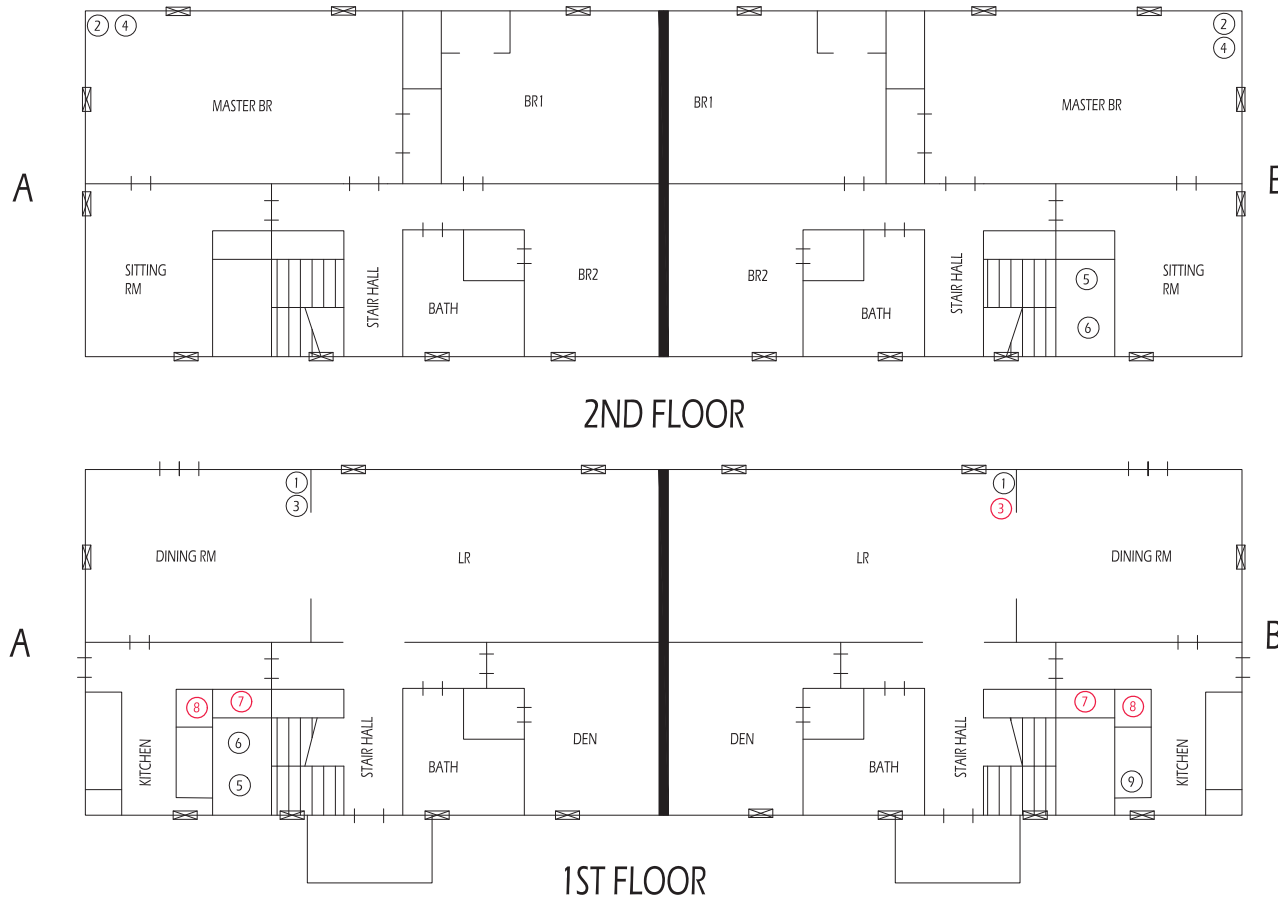
FIGURE 2
FORT MCPHERSON - ACM
SAMPLING LOCATION PLAN
BUILDING 506
ATLANTA, FULTON COUNTY, GA

crushed or pulverized by hand pressure. **Laboratory results revealed that five (5) of the samples analyzed contained >1% asbestos in Building 506 (Units A & B) and included the following: vinyl sheet flooring and associated mastic (Units A & B), floor tile and associated mastic (Unit B), and plaster wall coating (Unit B).**

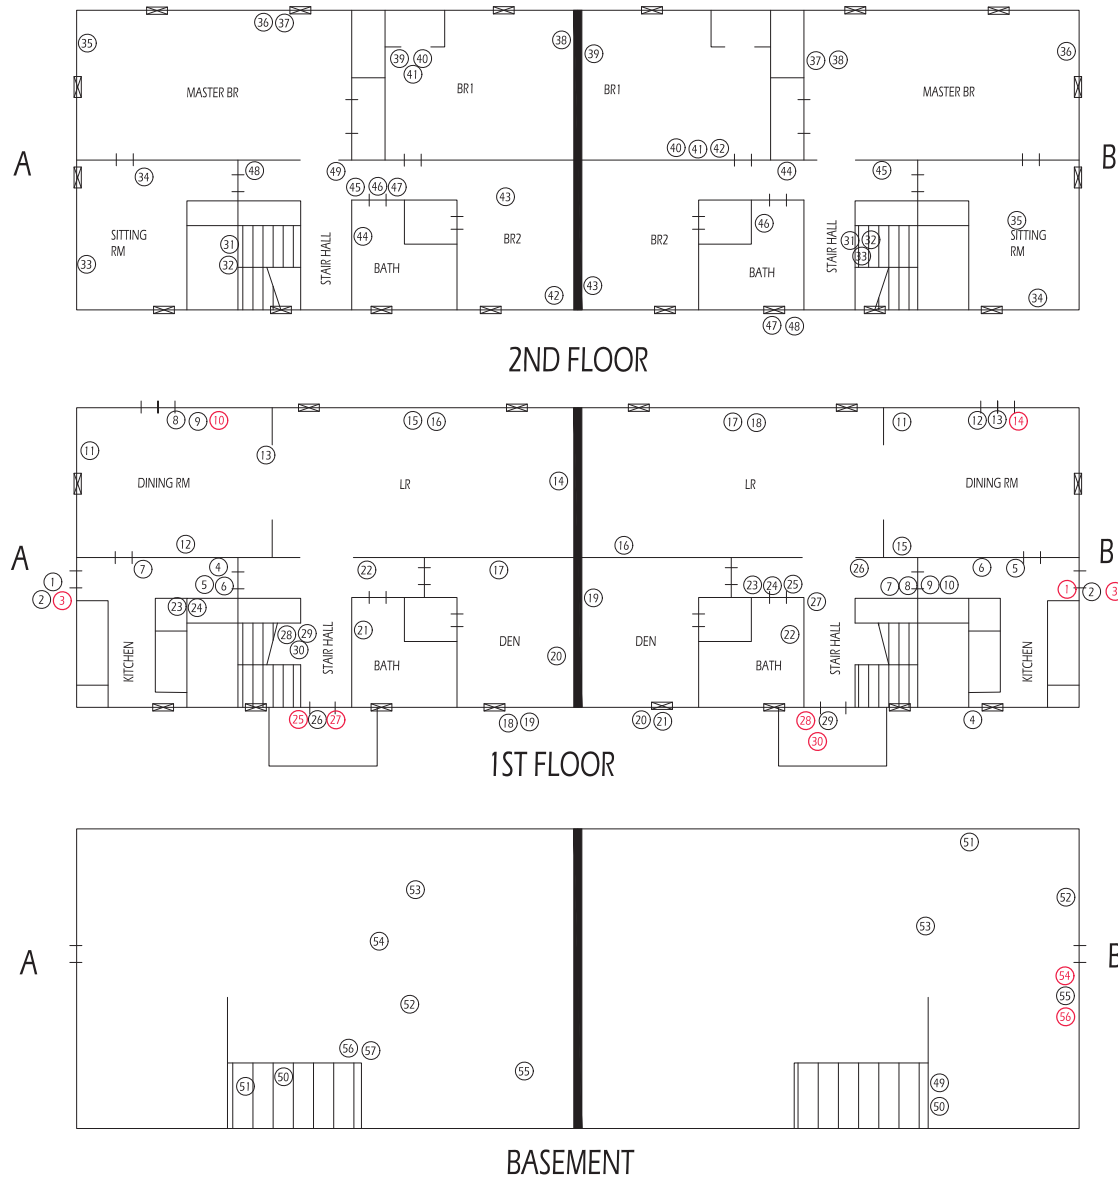
FIGURE 3
FORT MCPHERSON - LEAD-BASED PAINT
SAMPLING LOCATION PLAN
BUILDING 506
ATLANTA, FULTON COUNTY, GA

A total of 113 painted surfaces were analyzed using an x-ray fluorescence (XRF) analyzer. **Eleven (11) of the painted surfaces contained lead concentrations in excess of 1.0 mg/cm²; therefore, the paint is considered to contain elevated lead content.** Interior painted surfaces that were positive for LBP consist of the following components: doors and door jambs in both Units of Building 506 and in portions of the basement. No LBP was found in the interior portions of the 2nd floor Units of Building 506.

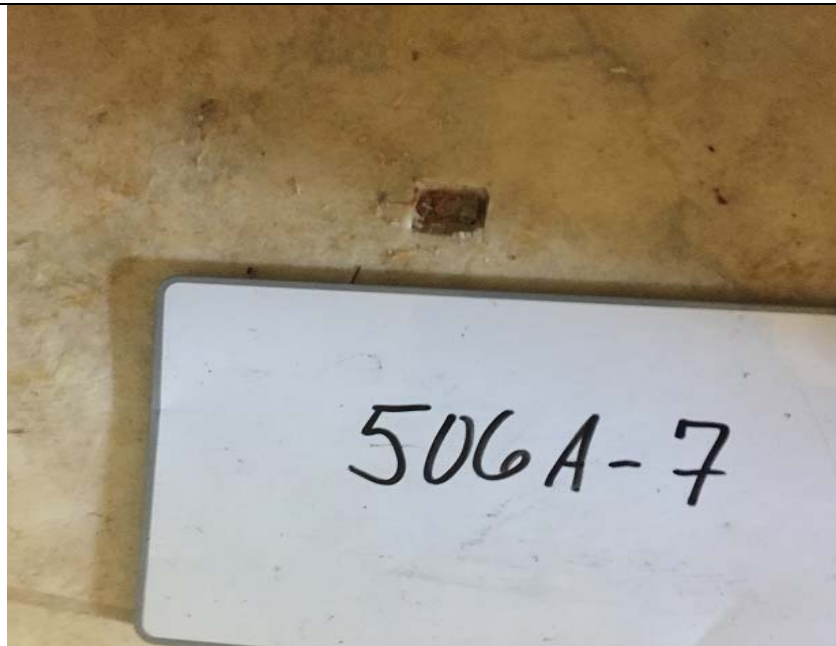
Photograph: 3

Gray vinyl sheet flooring with mastic sampled from the Kitchen of Building 506 Unit A.

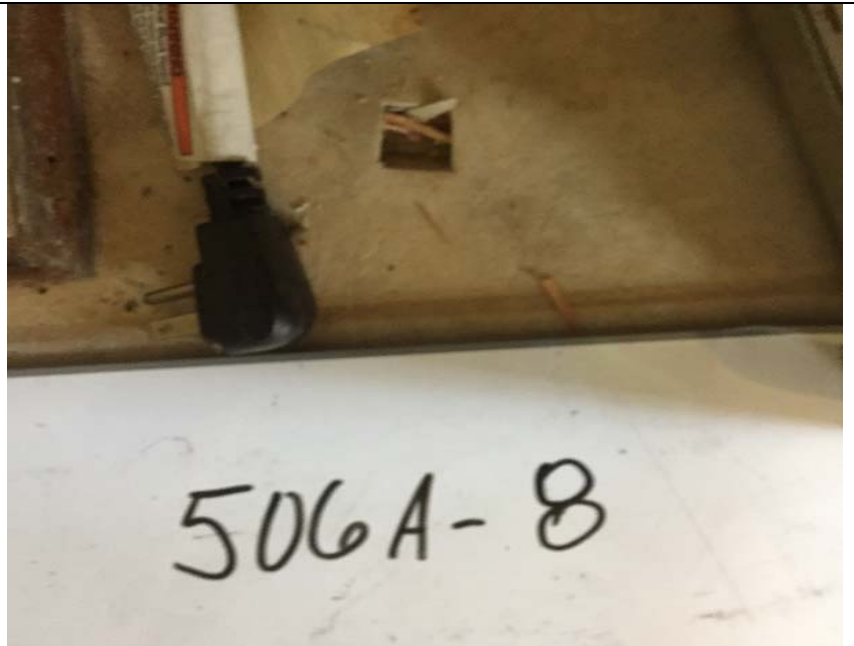
Photograph: 4

View of the Kitchen in Building 506 Unit A where gray vinyl sheet flooring with mastic was sampled.

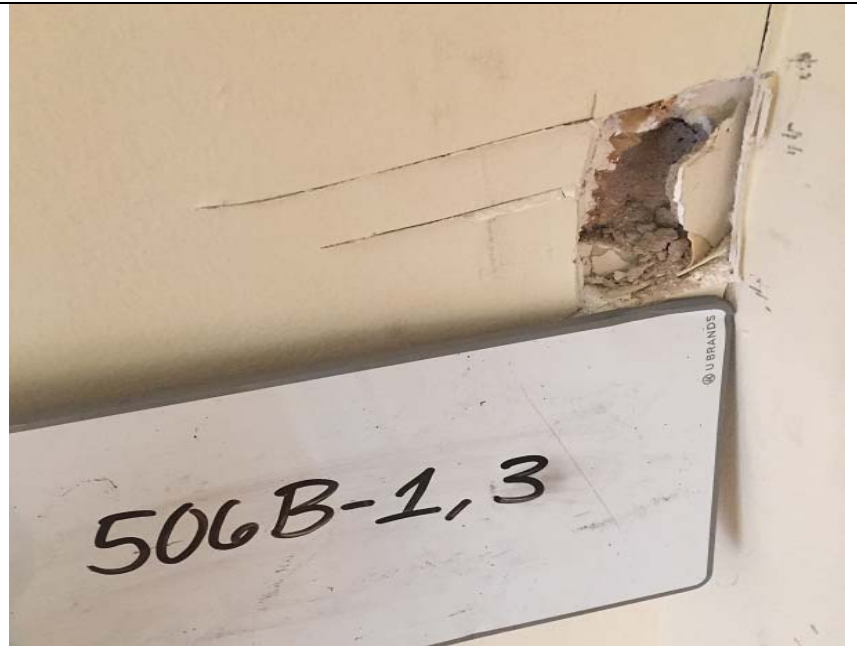
Photograph: 6

View of the Living Room
in Building 506 Unit B
where plaster wall with
coating was sampled.

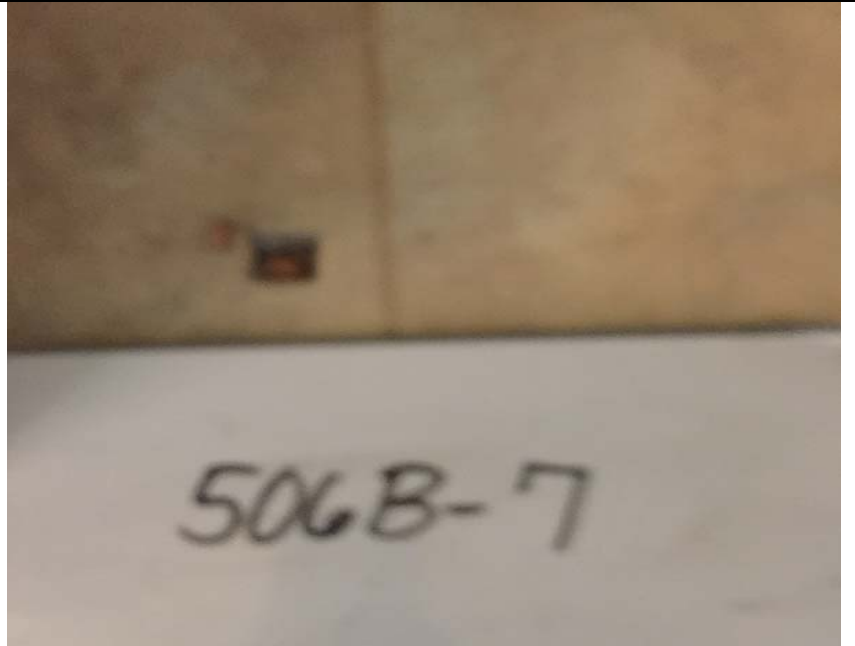
Gray vinyl sheet flooring with mastic sampled from the Kitchen of Building 506 Unit B.

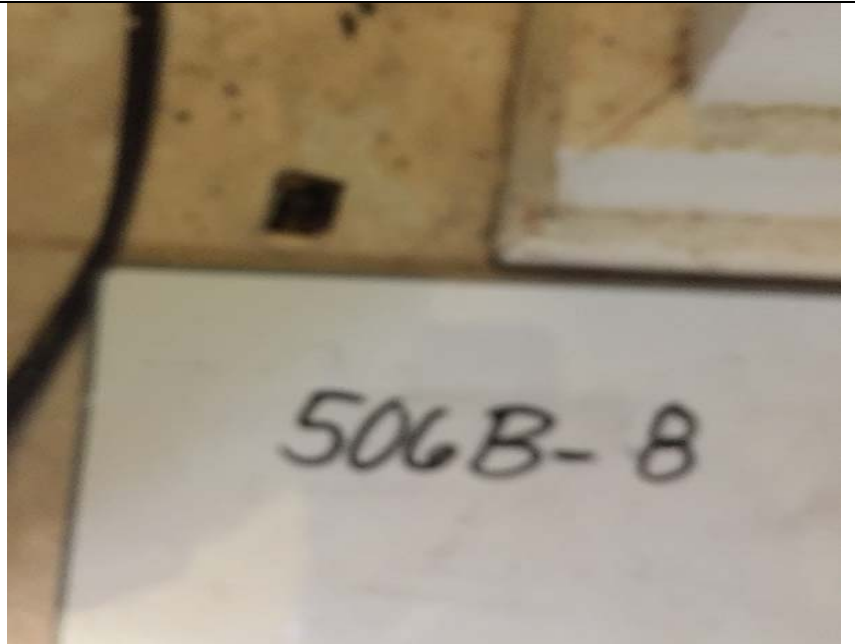
Photograph: 8

Gray vinyl sheet flooring with mastic sampled from the Kitchen of Building 506 Unit B.

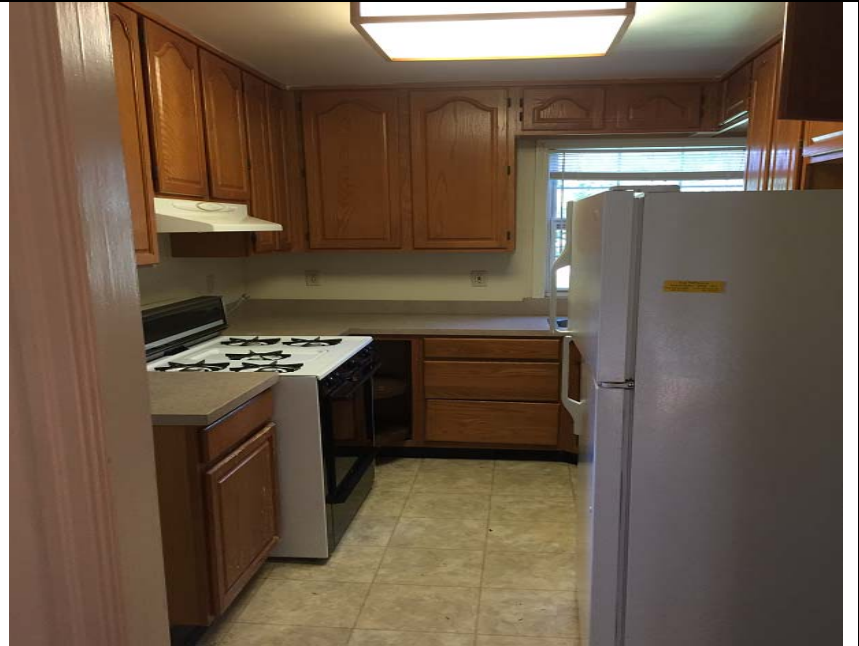
Photograph: 9

View of the Kitchen in Building 506 Unit B where gray vinyl sheet flooring with mastic was sampled.

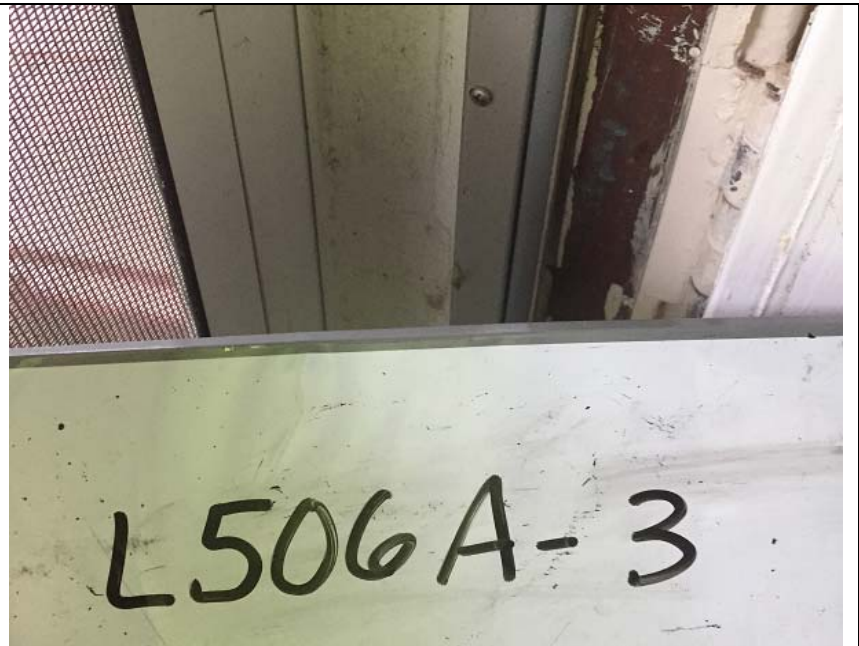
Photograph: 10

Sample Number	Color	Substrate	Building Material	Concentration (mg/cm ²)	Condition
Building 506					
506A-3	White	Wood	Door Jamb	>5.00	Paint Peeling/Flaking
506A-10	White	Wood	Door Jamb	>5.00	Paint Peeling/Flaking
506A-25	White	Wood	Door	>2.74	Paint Peeling/Flaking
506A-27	White	Wood	Door Jamb	>5.00	Paint Peeling/Flaking
506B-1	White	Wood	Door	>4.60	Significant Paint Peeling/Flaking
506B-3	White	Wood	Door Jamb	>5.00	Paint Peeling/Flaking
506B-14	White	Wood	Door Jamb	>5.00	Paint Peeling/Flaking
506B-28	White	Wood	Door	>4.60	Significant Paint Peeling/Flaking
506B-30	White	Wood	Door Jamb	>5.00	Paint Peeling/Flaking
506B-54	White	Wood	Door	>1.96	Paint Peeling/Flaking
506B-56	White	Wood	Door Jamb	>5.00	Paint Peeling/Flaking

Lead-based paint found on white wooden door jamb in the Kitchen of Building 506 Unit A.

Existing components that contain lead-based paint and have significant paint peeling and/or flaking should be addressed prior to building occupancy. These painted surfaces may be covered or encapsulated, or repainted/sealed with a thick non-lead encapsulation paint product. If elected, these materials could be removed/replaced (abated) by a licensed abatement contractor.

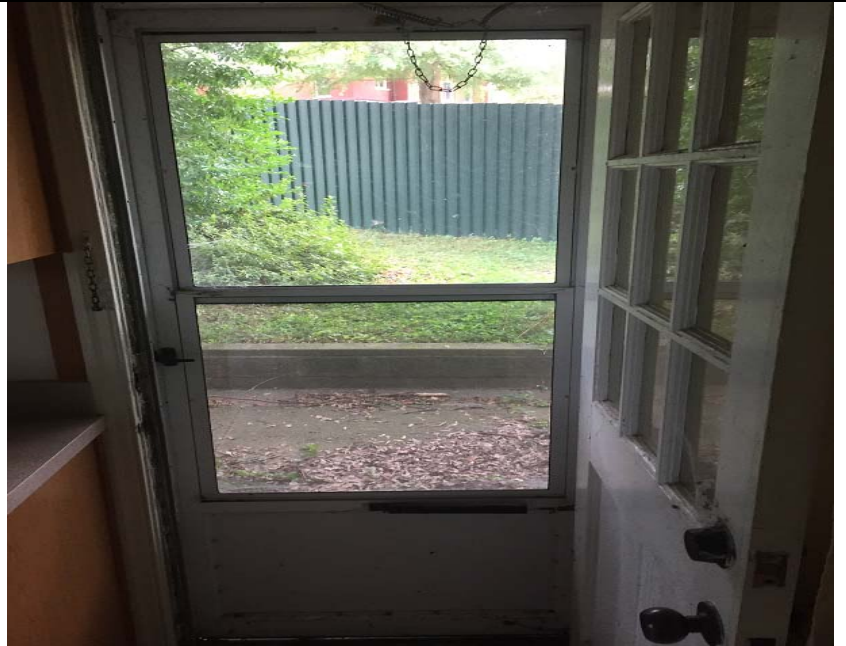
View of door where lead-based paint was found on white wooden door jamb.

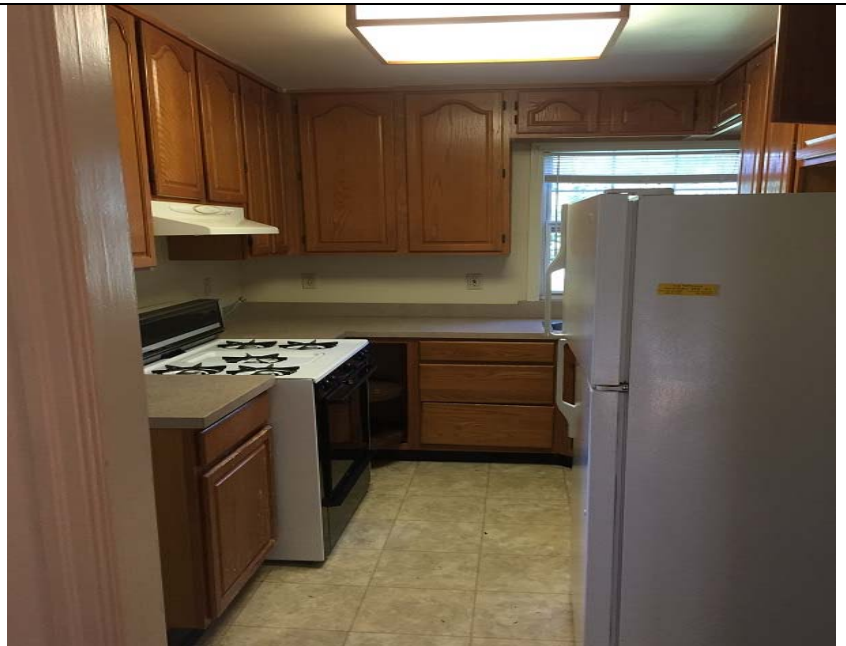
Photograph: 12

View of Kitchen in Building 506 Unit A where lead-based paint was found.

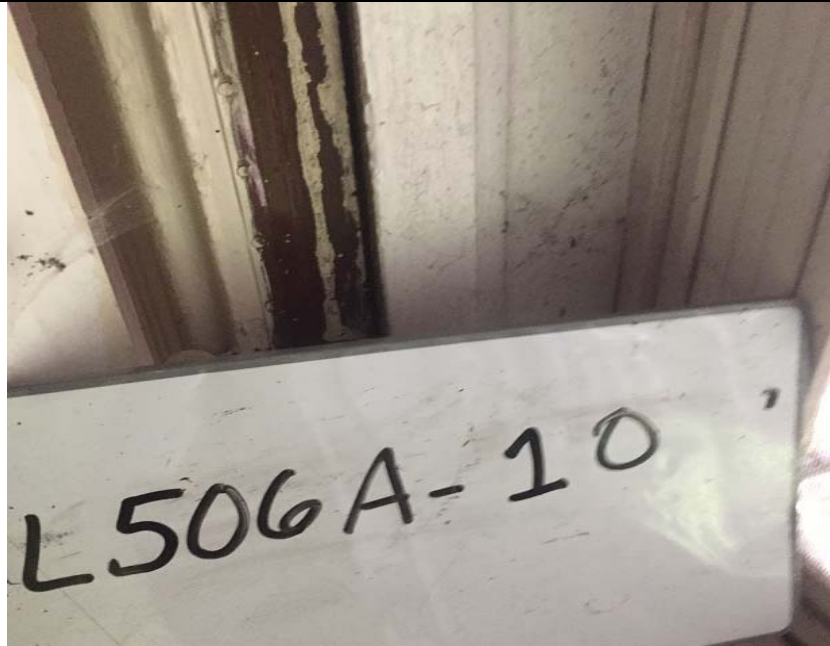
Lead-based paint found on white wooden door jamb in the Dining Room of Building 506 Unit A.

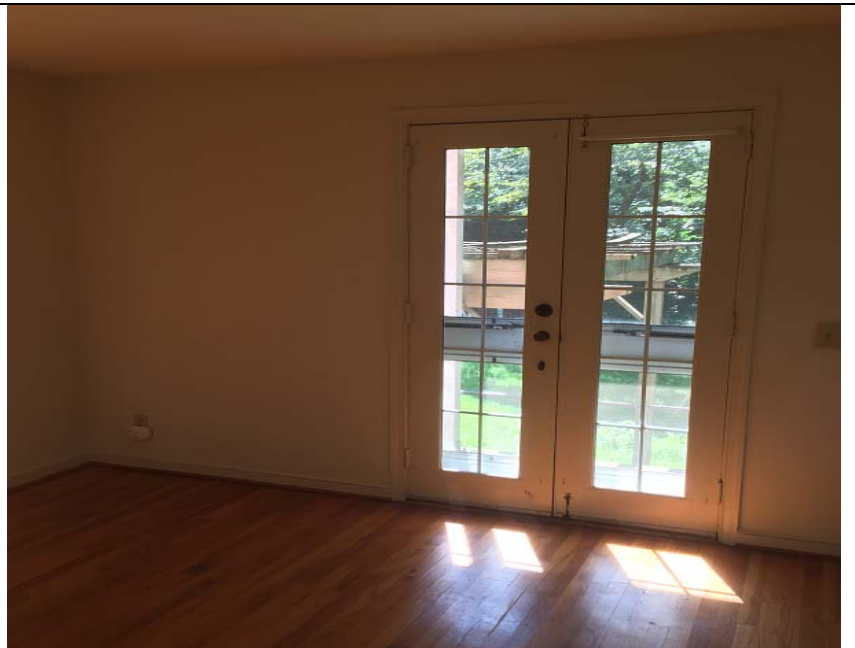
Photograph: 14

View of door in Dining Room of Building 506 Unit A where lead-based paint was found.

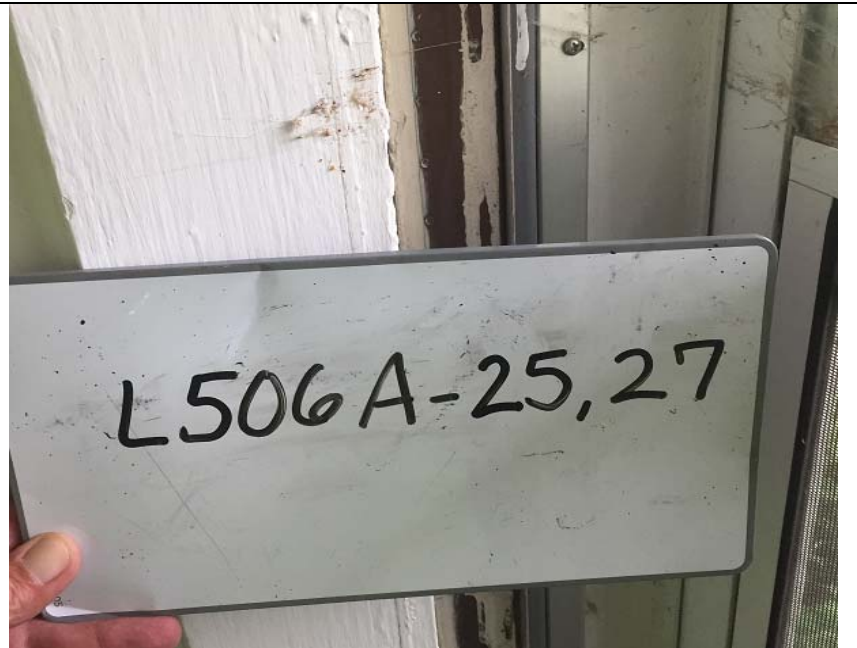
Lead-based paint found on white wooden door and door jamb in the Entry of Building 506 Unit A.

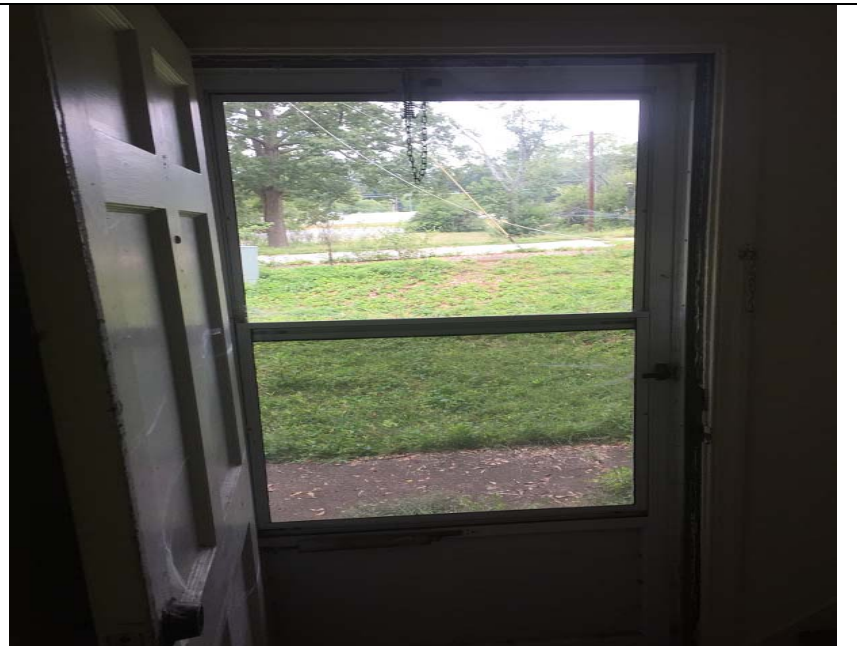
Photograph: 16

View of door in Entry of Building 506 Unit A where lead-based paint was found.

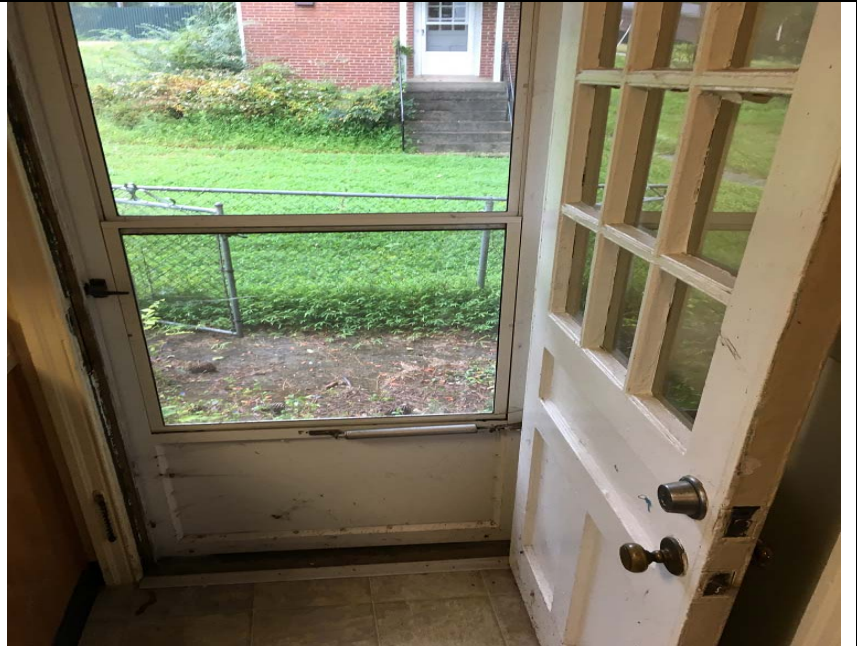
View of lead-based paint found on white wooden door and door jamb in the Kitchen of Building 506 Unit B (Sample IDs L506B-1 and L506B-3).

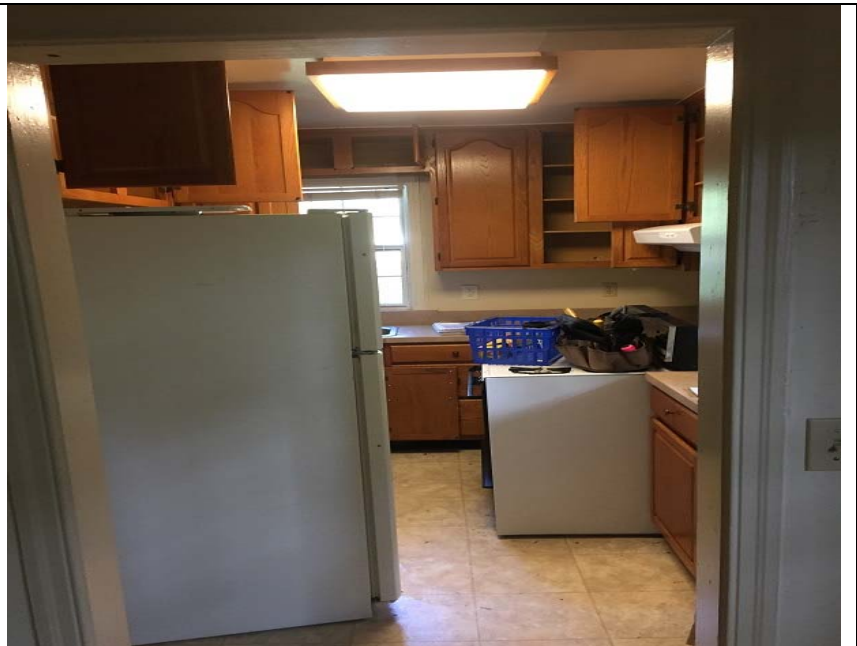
Photograph: 18

View of Kitchen in Building 506 Unit B where lead-based paint was found.

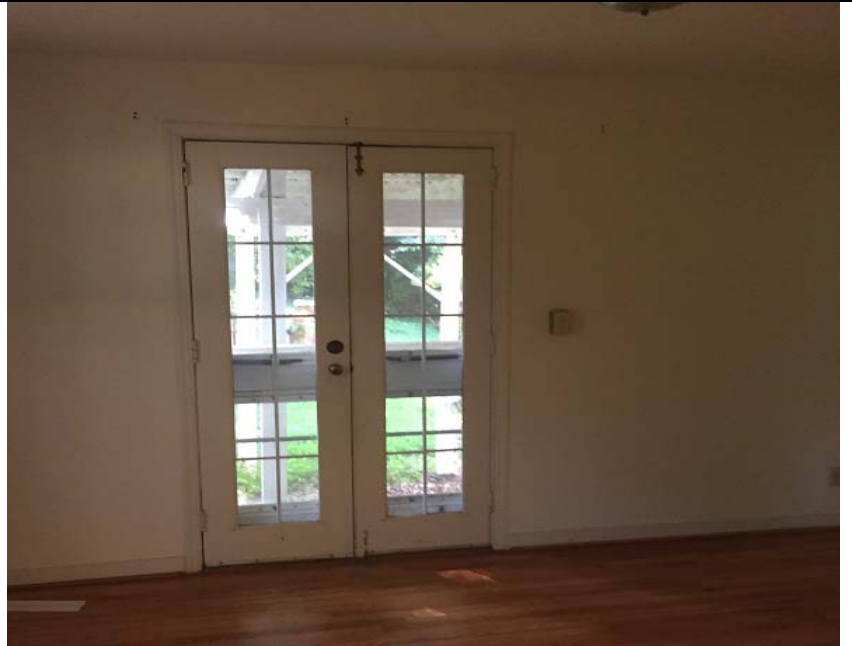
View of lead-based paint found on white wooden door jamb in the Dining Room of Building 506 Unit B (Sample ID L506B-14).

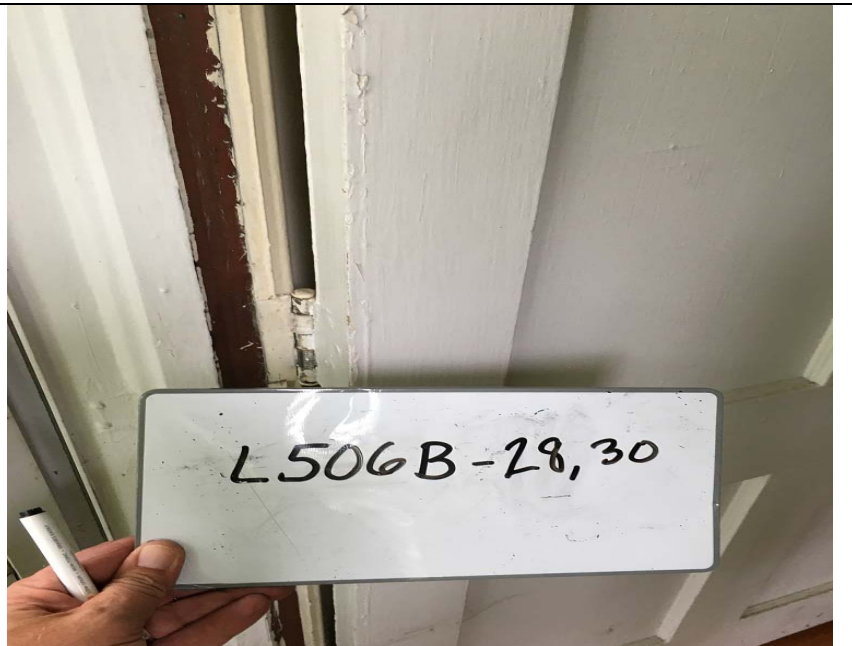
Photograph: 20

Lead-based paint found on white wooden door and door jamb in the Entry of Building 506 Unit B.

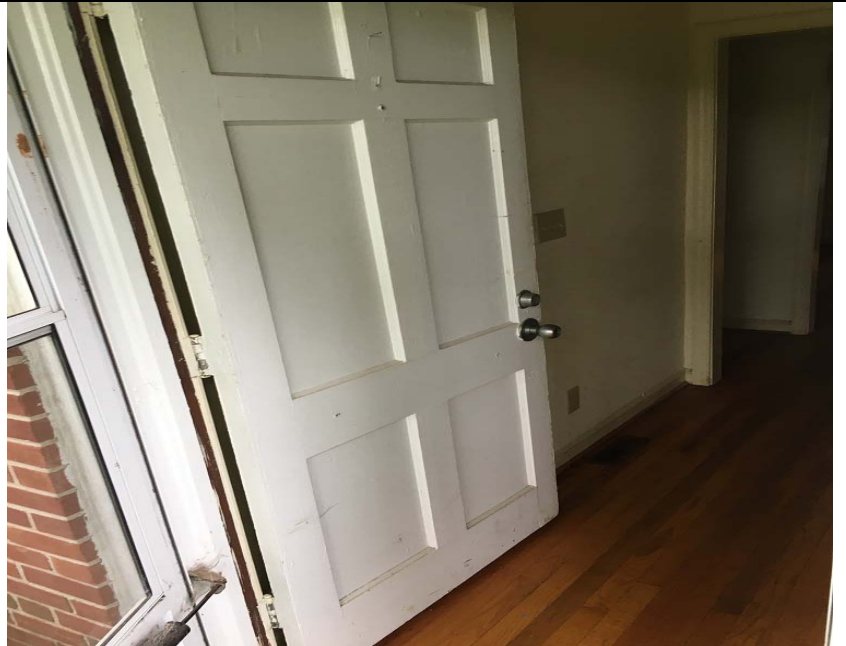
View of door in Entry of Building 506 Unit B where lead-based paint was found.

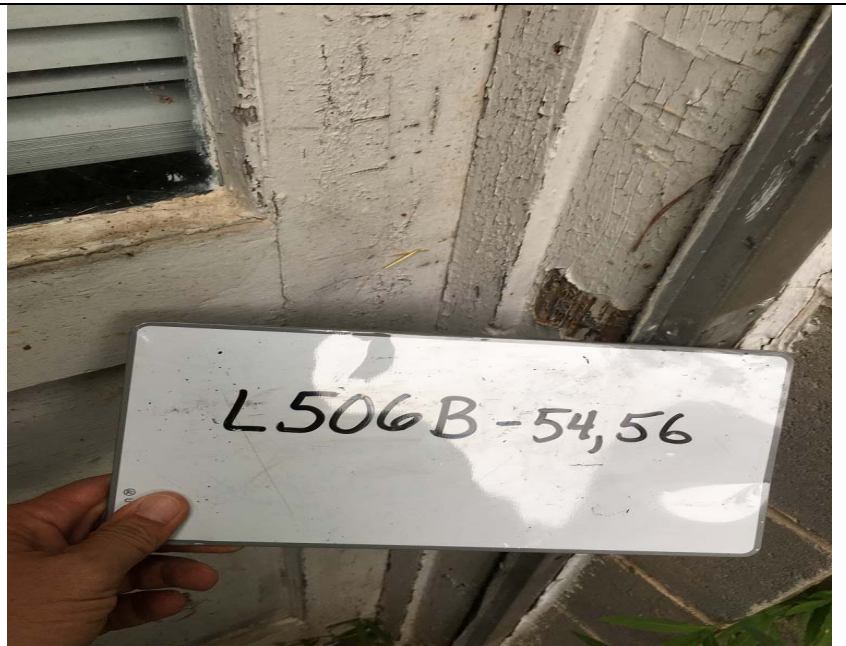
Photograph: 22

Lead-based paint found on white wooden door and door jamb in the Basement of Building 506 Unit B.

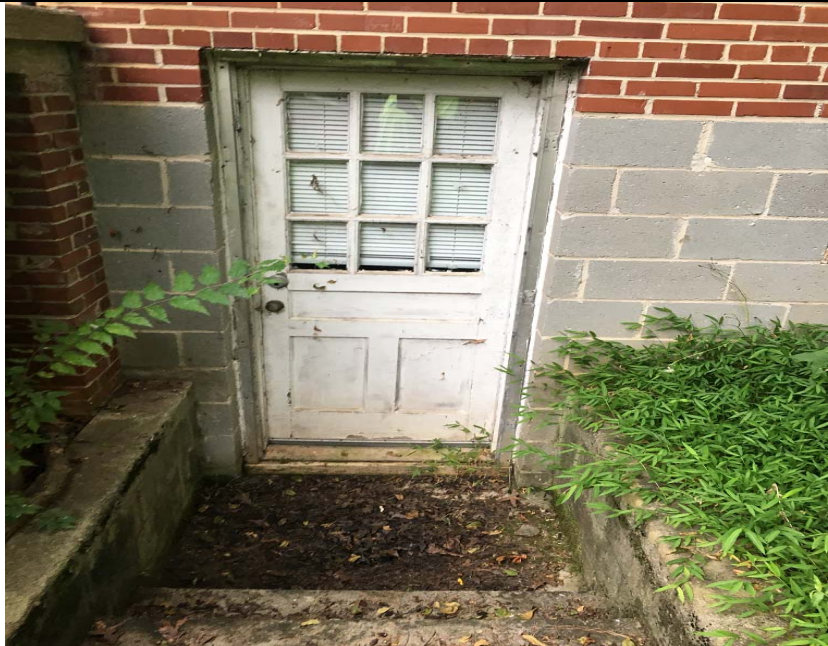
View of door in Basement of Building 506 Unit B where lead-based paint was found.
